- 1. Definition of Vibration & Introduction to Predictive Maintenance.
- 2. Advantage of Vibration monitoring instrument.
- 3. Types of Vibration monitoring instruments.
- 4. Portable Vibration monitoring device.
- 5. Fixed / attached Vibration monitoring device.
- 6. Case study.
- 7. Future developments.

1. Definition of Vibration

2. Fixed type – continuous monitoring VIBRASWITCH 66W (fitted in M class vsls HFO purifiers).

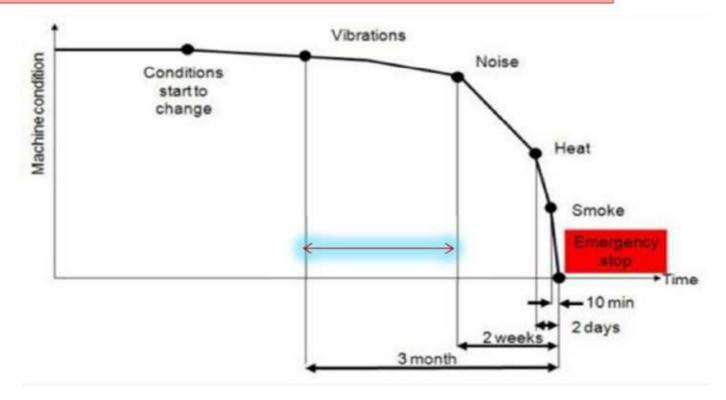
Figure shows a typical machine failure example and the warning signs.

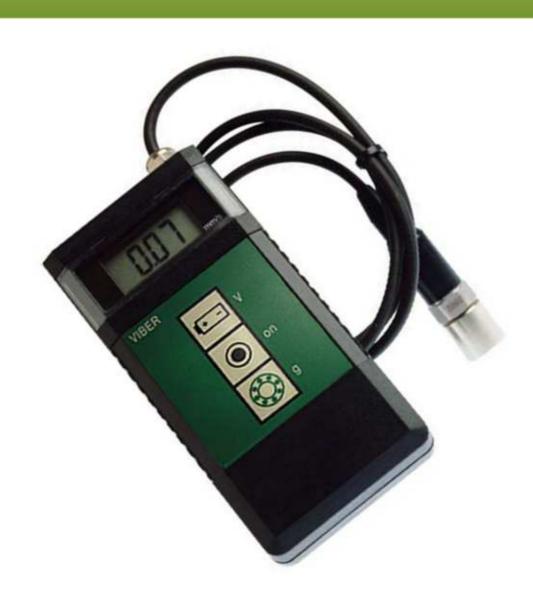
1. Portable type - Viber-A

TECHNICAL SPECIFICATIONS VIBER-A

- **INPUT SENSITIVITY:** 100mV/g calibrated at 156,15 Hz.
- MEASURING RANGE: Velocity: 0-200 mm/s RMS
- FREQUENCY RANGE: Total level 10-3200Hz, 3000~20000Hz
- The measurement mainly follows ISO 2954.
- **BATTERY TYPE:** 9V 6F22 or similar
- VIBRATION TRANSDUCER
- The accelerometer IMI608A11 has a sensitivity 100mV/g +/-10%.
- MAGNET SUPPORT
- Length: 20mm, Diameter: 15mm, Magnet force: about 14kg.
- EXTENSION TIP
- Length: 65mm

- It's a fully portable instrument used in preventive maintenance work on rotating machinery.
- It comprises an *instrument*, a *vibration transducer* with *magnet support*.
- Used for measuring the effective velocity (mm/s RMS)
- In the frequency range between 10 and 3200 Hz.
- This range covers most of the frequencies that will occur for the majority of *mechanical malfunctions and imperfections*.

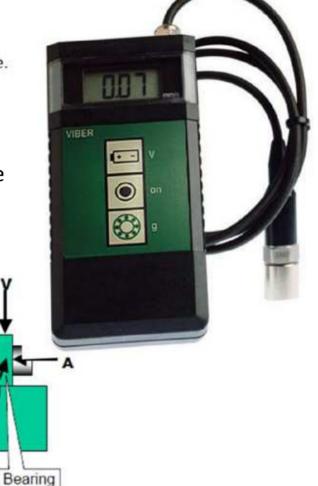
Bearing condition

Press this symbol key and keep it pressed. The instrument measures instantaneously a bearing condition value in the range between 3.200Hz to 20.000Hz.

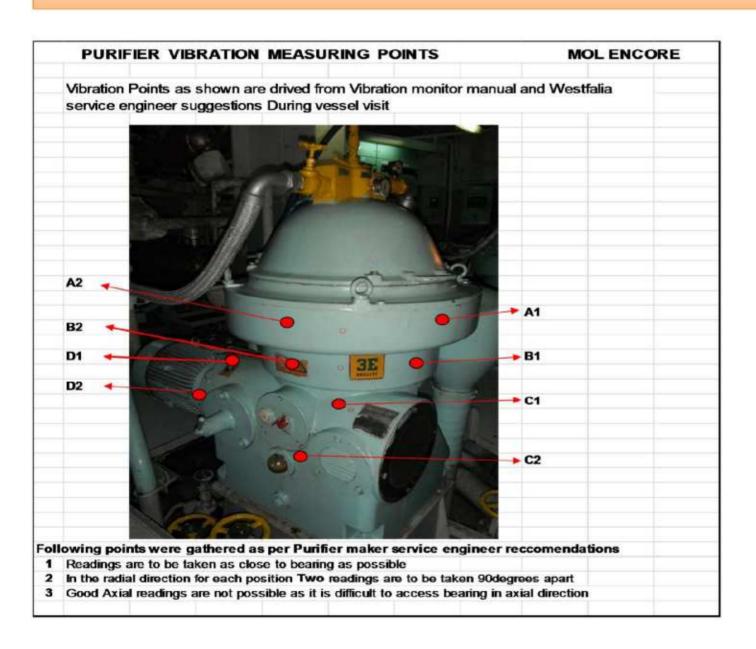
Measuring points for Purifiers

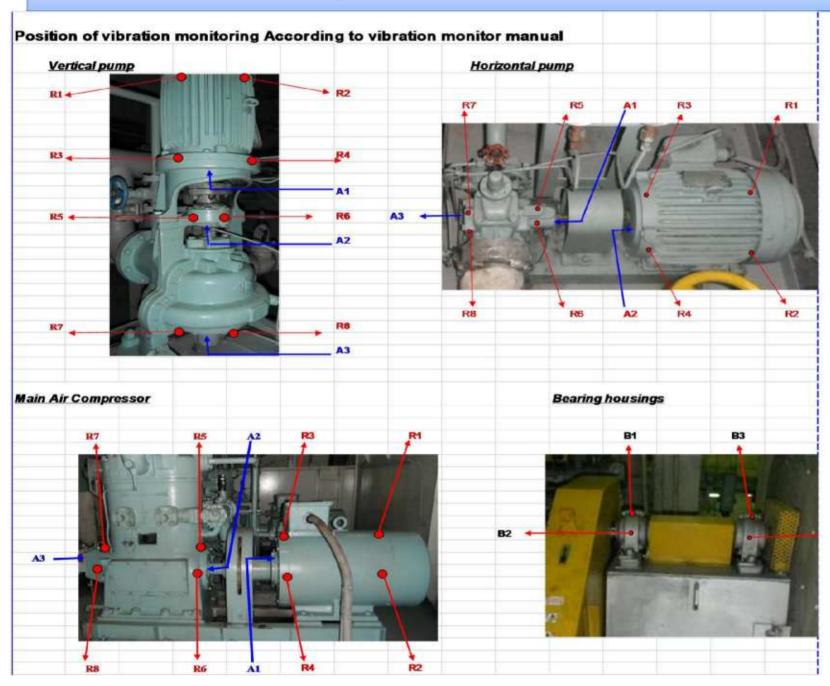
Measuring points for Motors & Pumps

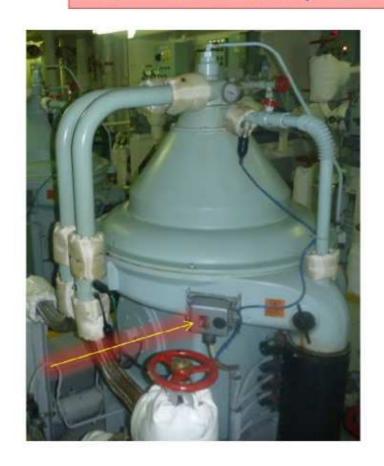
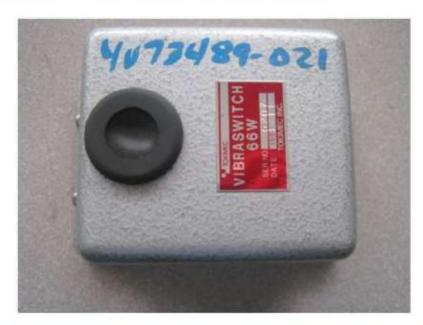
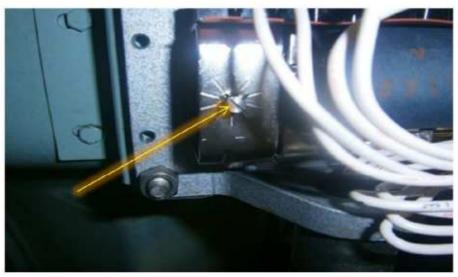
2. VIBRASWITCH 66W (FITTED IN M CLASS VSLS HFO PURIFIERS).

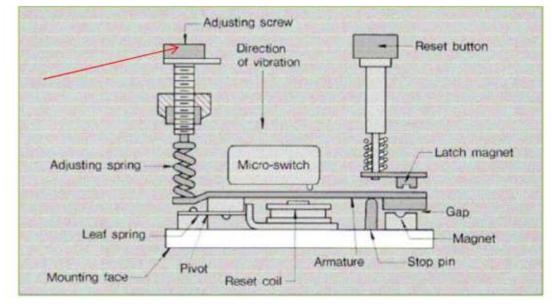
Construction of the Detector;

If the detector is subjected to vibration, a moment will be set up around the spring joint of the armature, tending to separate the armature from magnet below it. Similarly the Adjusting spring is also generating the moment tending to separate the armature from magnet. When the sum of these moments is larger than the moment acting around the spring joint due to the attracting magnet, the armature will come away from the stop pin below and triggering the micro switch there by the machine stops or

an alarm is given.

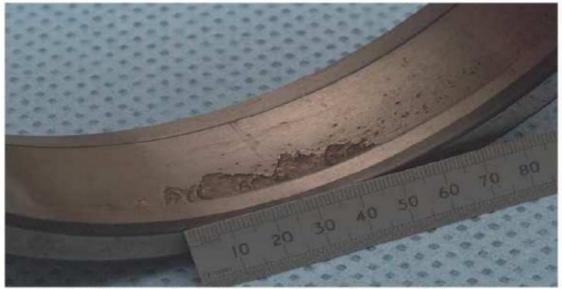
Figure 4 - Photograph showing bearing outer race damage

The machine was subsequently taken off line and the bearing replaced. On examination of the original bearing, a large area of flaking (spalling) was evident on the outer race, see Figure 4.

Due to the accurate analysis and prompt action by the Engineering Department a catastrophic failure had been prevented with a mechanical cost saving of several thousand pounds.

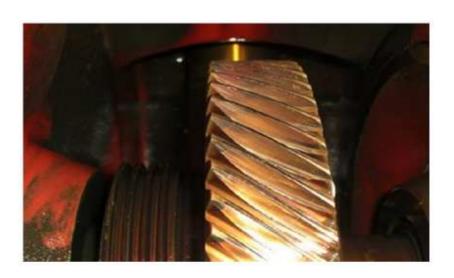
MOL Encore #1 HFO purifiers trouble case again during Oct. 2011.

- Heavy oil purifier #1 sudden damage to worm wheel- 3rd October 2011.
- During morning rounds of machinery on, noticed higher amperes 25
- A (normally about 23A) and slight vibration in HOP #1.
- Purifier immediately stopped and bowl assembly removed for inspection.
- Found excess sludge accumulation in the sliding piston. Disc stack is mostly
- clean. Rhrs since last cleaning is 288 hrs.
- Inspected the gear case and found worm wheel gear worn out. Teeth width is
- now of 2.2 mm (minimum recommended 2 mm). Last measured value of gear teeth
- width was 3.6 mm.

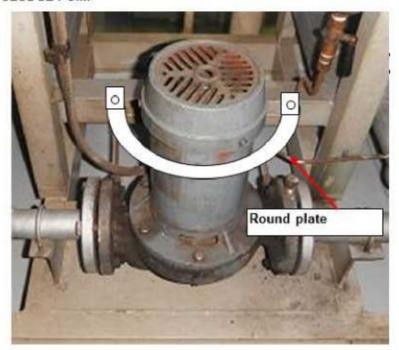
SLUDGE PUMP

Arrangement to Reduce Vibration

A round plate to be provided around the Motor with rubber packing on the round plate as well between motor and frame.

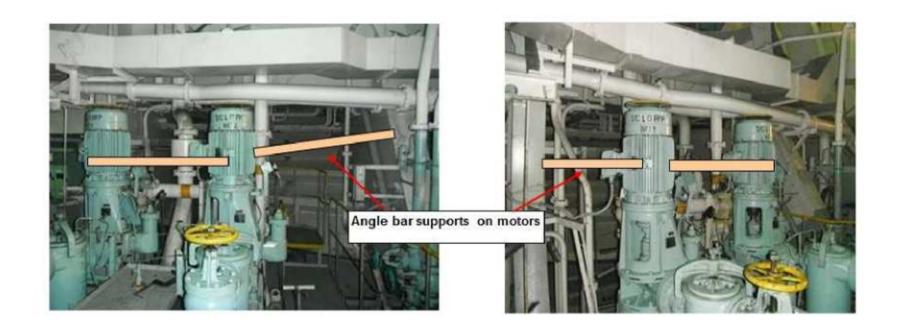
Corrective action taken for excessive pump vibration

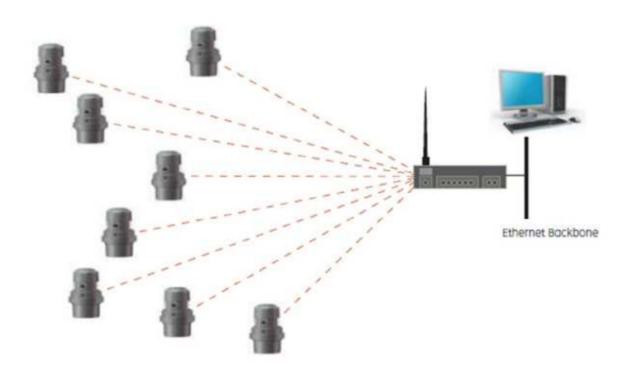
Wireless Vibration monitoring system;

Each field device can communicate with the wireless gateway and from the Gate way the collected information is analyzed / recorded & alerted with an alarm if the value exceed the normal set point.
